# Property Flood Resilience

Stories from homes and businesses who have made adaptations to help them recover more quickly after a flood

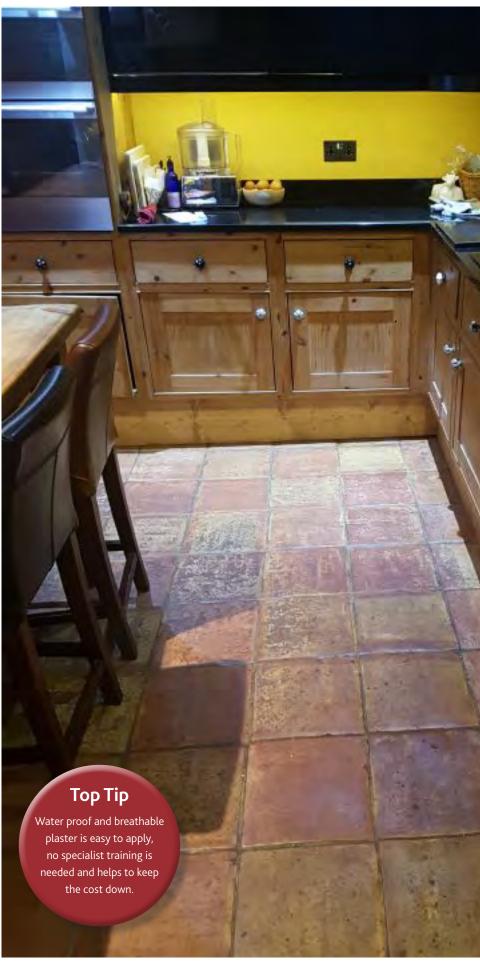
As you can see, this solid wood kitchen fitted in 2012 survived the 2015 flood.

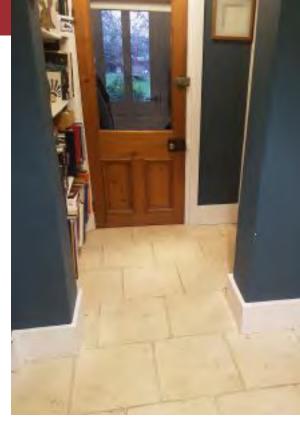
All the items shown here have survived one or more floods.

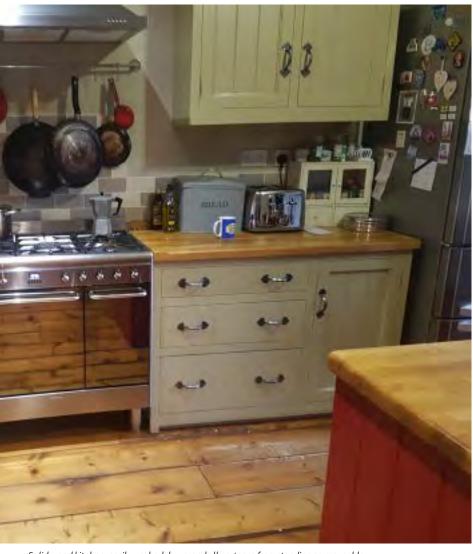
Solid wood kitchen, easily washed down, and all parts are free-standing so moveable.

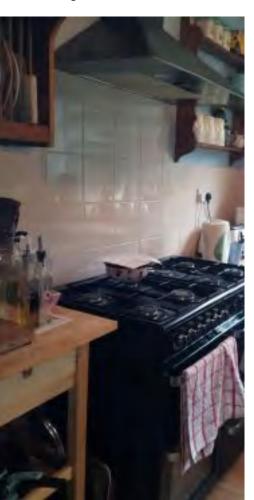
Solid wood kitchen units are freestanding so can easily be removed.

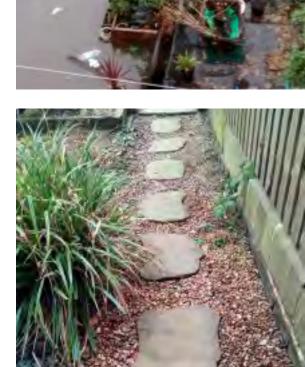
Permeable pathway.

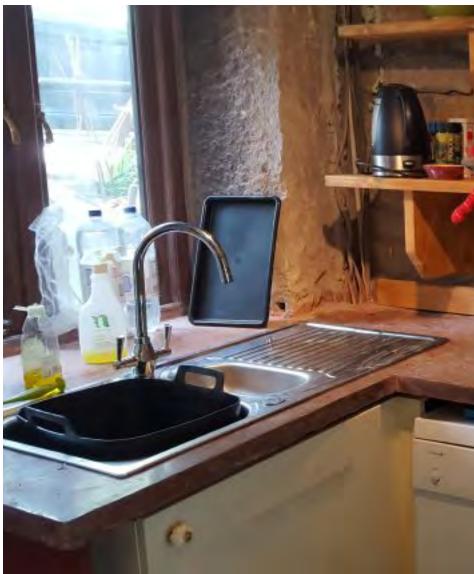
The kitchen worktop is polished concrete and was saved in the flood

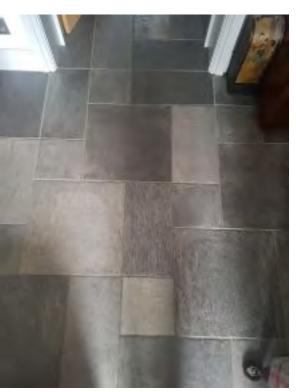
Tiling in the ground floor above insulation and underfloor heating.

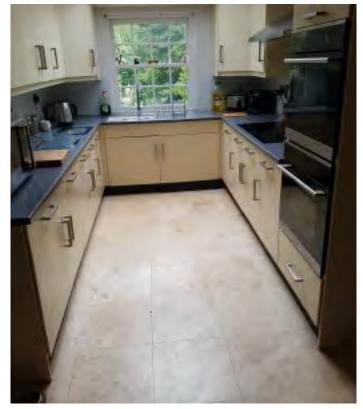
A Corian plastic kitchen was fitted.

He decided that because the kitchen was the most expensive item to replace, he would have a Corian plastic kitchen fitted. It appears that the company is no longer in existence, but a quick web search showed that Corian and laminated Aquoline kitchens are still available. He has stone tiled floors that survived the floods and now also has waterproof plaster on the walls.

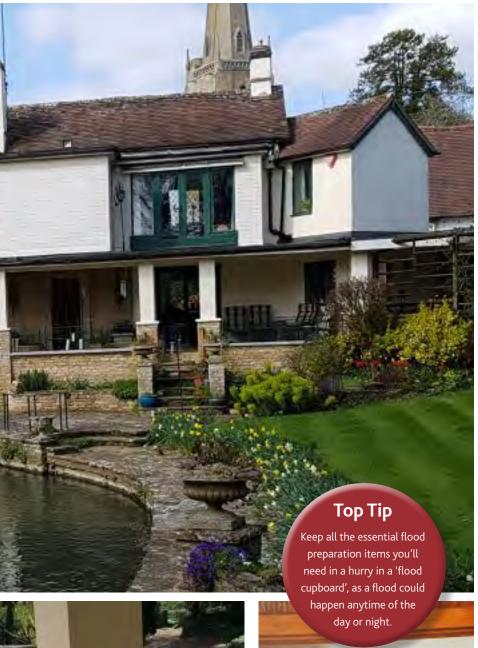
The glass barrier with floodgate for access on river-facing side.

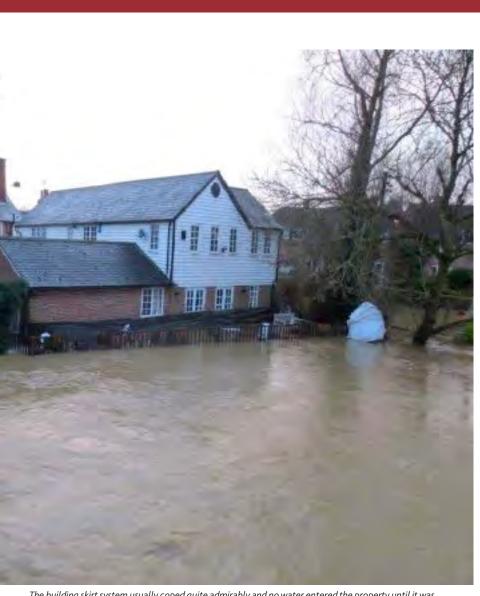
$The \ building \ skirt \ system \ usually \ coped \ quite \ admirably \ and \ no \ water \ entered \ the \ property \ until \ it \ was \ overtopped \ in \ 2013.$

However, the 2013 flood overtopped the building skirt system and seriously damaged the house.

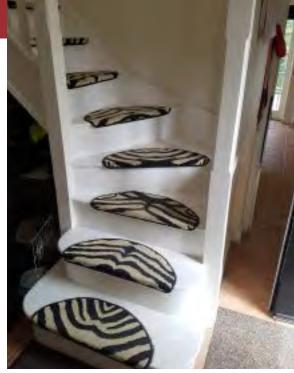
The staircase has only minimal carpet, which can easily be replaced.

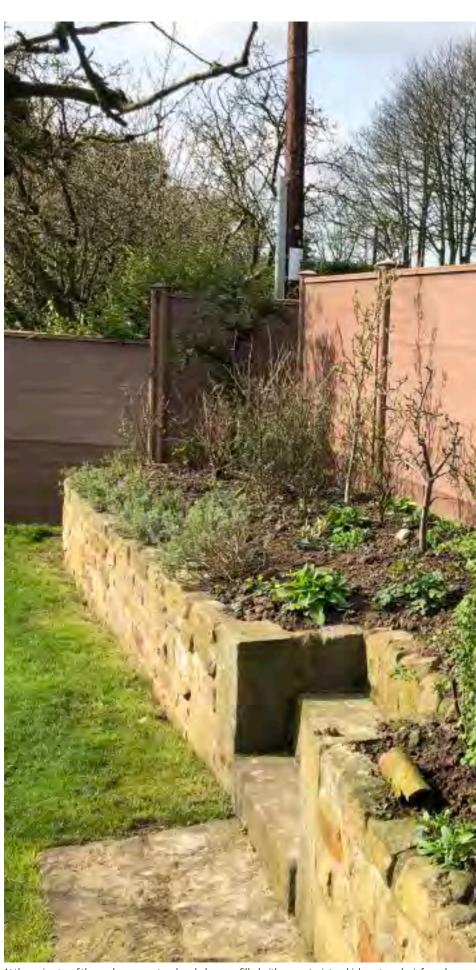
At the perimeter of the garden one-metre-deep holes were filled with concrete, into which posts and reinforced 'Task Green' waterproof fence panels were fitted.

- Plaster was replaced with a lime-based mix.
- Plug sockets were raised up the wall.
- At the perimeter of the garden their contractor dug one-metre-deep holes, which were filled with concrete, into which 'Task Green'\* waterproof posts and fence panels were then fitted, with the lowest panel sunk into a 2ft trench, also filled with concrete. The contractors also reinforced the fence panels with steel bars, to enable them to withhold the weight of deep water.

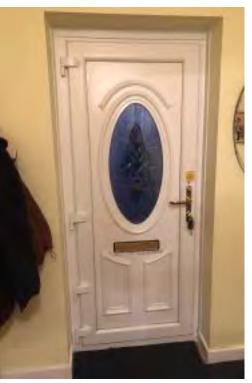
Flood resilient front door has been installed.

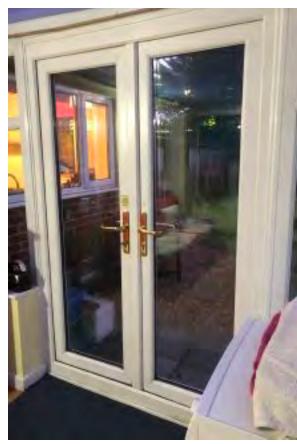
Flood resilient patio doors have been installed.

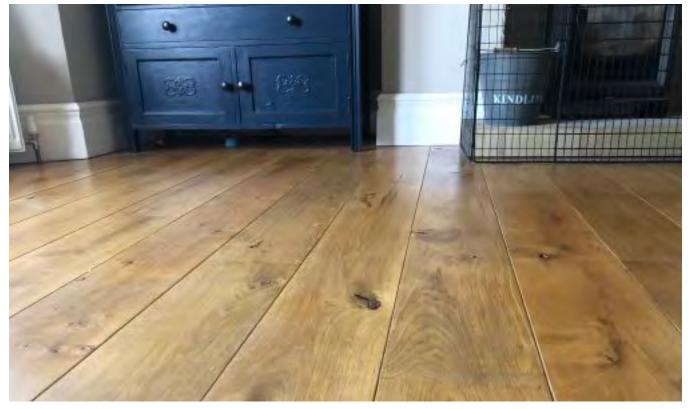
$Hard \, wood \, flooring \, with \, rugs \, replace \, the \, carpets \, which \, were \, a \, night mare \, to \, lift \, out \, and \, dry \, following \, the \, flood.$

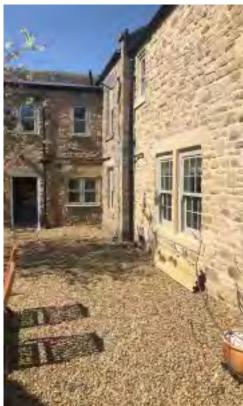
Permeable patio areas surround most of the house.

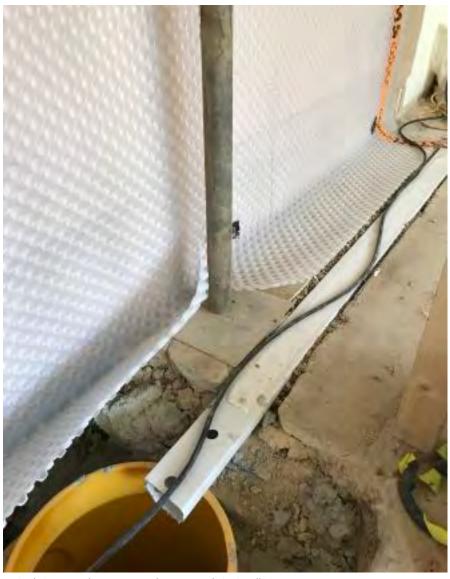
Cavity drainage membrane system and sump pump during installation.

It was obvious that this problem would reoccur (likely with increasing frequency due to climate change), so a specialist survey was undertaken with an ensuing recommendation that a cavity drain waterproofing system be installed, along with a small packaged pumping station. The work was carried out by a specialist membrane provider and is a typical structural waterproofing solution, where external ground levels are high and there is a likelihood of the presence of water.\*

\*These systems do not provide a hydrostatic barrier but provide protection by means of water management.

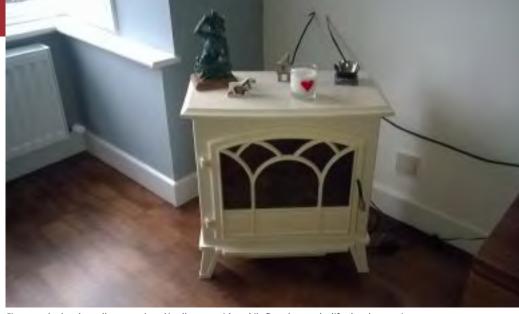
Fires attached to the wall were replaced in all rooms with mobile fires that can be lifted at short notice.

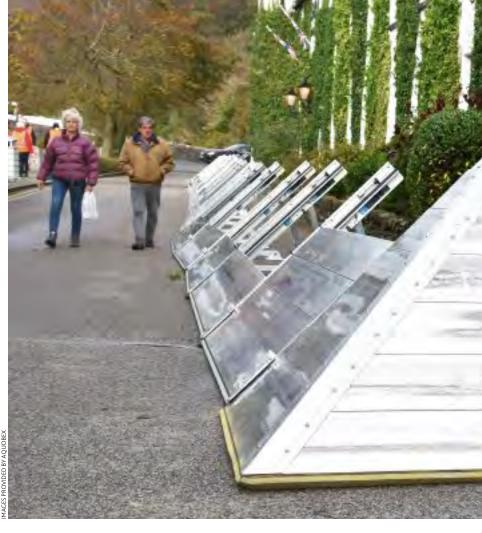
Rigid temporary barriers are installed around the hotel to a height of 1.2 metres
 The hotel has 'Flood Marshals' trained to put the barriers in place, which take 6 people about 1.5 hours.

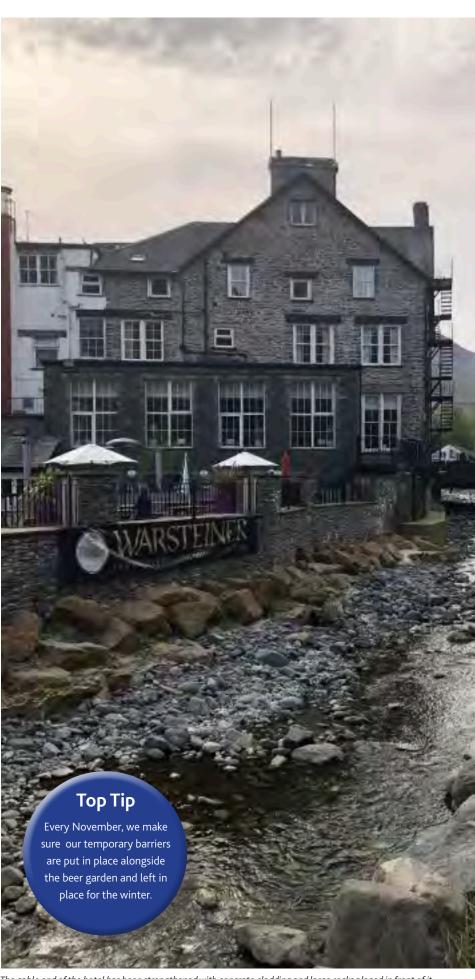
The gable end of the hotel has been strengthened with concrete cladding and large rocks placed in front of it.

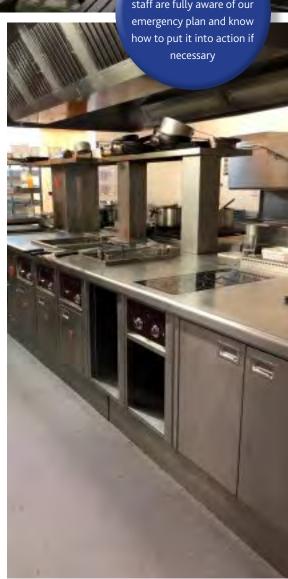
The motor can be removed from the stainless-steel kitchen 'Chave block' (cooking area).

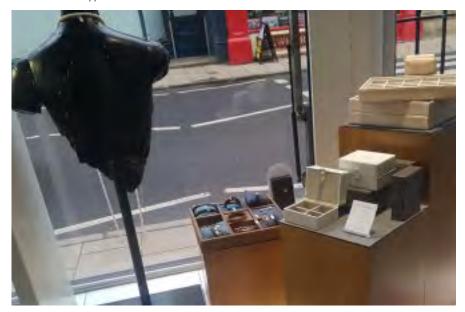
The display windows have bracing that can be lowered when needed, to protect the glass from water pressure.
