Derbyshire
Stone Slate Roofs

**Guidance
for Owners
of Historic
Buildings**

TRADITIONAL STONE ROOFING - DERBYSHIRE STONE SLATE ROOFS

GUIDANCE FOR THE OWNERS OF HISTORIC BUILDINGS

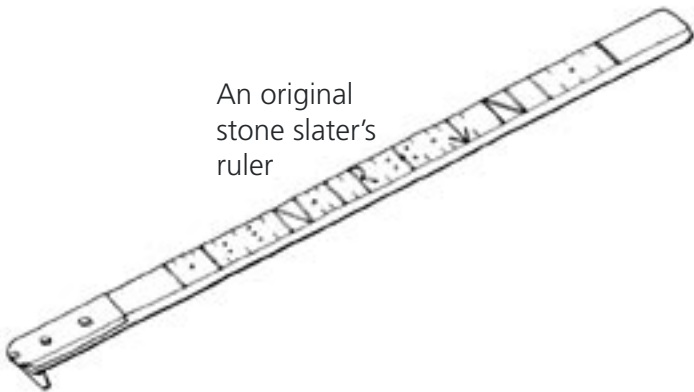
An original stone slater's ruler

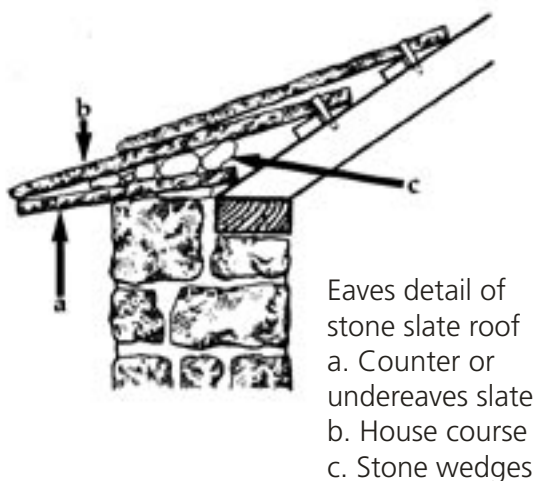
Eaves detail of stone slate roof
 a. Counter or undereaves slate
 b. House course
 c. Stone wedges

Detail of stone ridge, showing means of supporting the joints

At the ridge, the roof was finished with ridge stones cut from the solid with pick and chisel or, later, sawn. Farey makes reference to 'Coburn Quarry' on South Winfield Park where 'Ridging Stones, a substitute for Ridge Tiles, are

prepared. They are sawn out like an angular 'trough', whilst at 'Mansfield, Nottinghamshire and at Kinder in Glossop, they are hewn out for rough buildings'. Sometimes the ridges were bedded on mortar, sometimes they were laid dry, but in other instances the joint between two ridge stones was bedded onto a small pile of broken slate, with mortar, to give the area some support. The ridge stones varied in size and angle, according to the pitch of the roof. On a gabled building, unless the wall was finished with coping stones, the stone slates were carried onto, and sometimes beyond, the line of the outer stonework, but obviously copings would have made a more satisfactory finish.

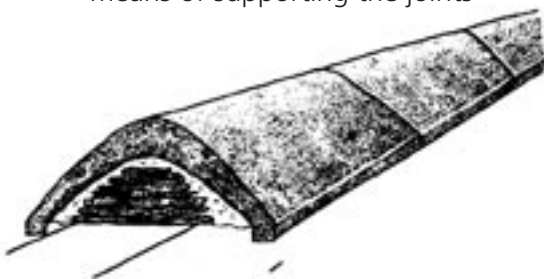
Stone ridge tiles showing the method of support

The final course of slates, nearest the ridge are bedded, rather than nailed, and then the stone ridges are laid. They can be supported in the manner described earlier.

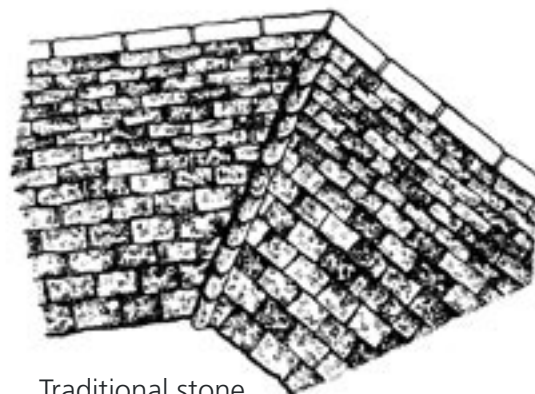
Traditional stone valley detail showing pointed valley slates

Roof valleys were a particular problem on stone slate roofs, as it was particularly difficult to achieve a swept or laced valley as was possible with thin Cotswolds limestone slates or plain tiles and which meant that the coursing of the stone covering was not drastically interrupted. In Derbyshire, and in the Pennines, the valleys were formed by laying stout boards in the valley space to provide support for chevron ended valley slates which were laid to form a stone valley. The edge slates of the two intersecting roof slopes were mitred to the required shape, and the valley was so constructed as to allow the coursing to continue from one slope to the other, although the valley course was set below the other courses and was partly oversailed by the edge slates of the adjacent roofs.

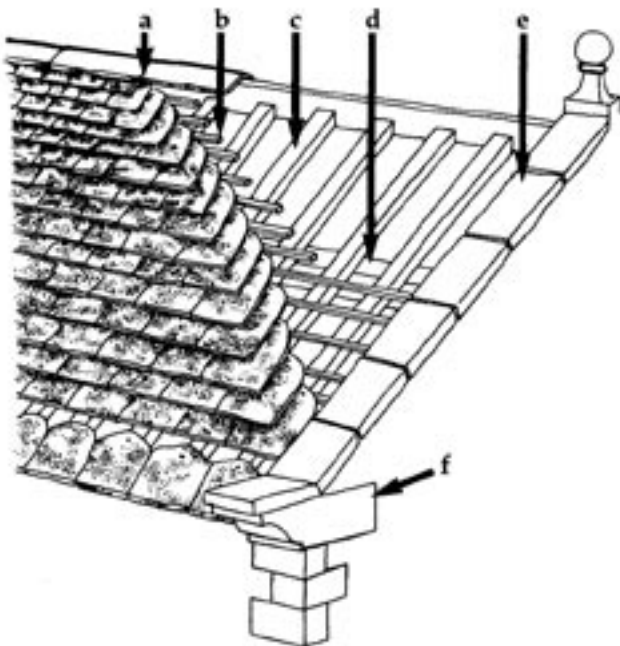
The components of a stone slate roof (with eaves course exposed and second course omitted to show lap).

- a. stone ridge
- b. laths or battens
- c. spars
- d. purlin
- e. coping
- f. kneeler

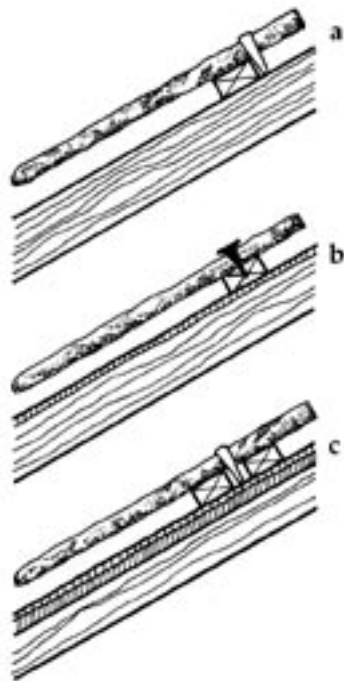
- Methods of fixing stone slates:
- pegged slate on single batten.
 - nailed slate.
 - pegged slate, using double battens

As has been shown, stone slates were traditionally hung using oak pegs, although other materials, notably animal bones, were used and there are even references to stones being bedded in mortar rather than hung. Today, with the use of underfelts and membranes, the pegging of slates is impracticable, unless the roof is counter battened that is, battens laid onto the backs of the spars, over the top of the felt, prior to the slating battens being fixed. This gives sufficient depth in which the pegs carrying the slates can be accommodated without harming the felt. The use of pegs is obviously the most acceptable method of hanging slates from a traditional viewpoint but there are the disadvantages of shrinkage, twisting and slipping associated with the use of wooden pegs, and there is a school of thought which contends that unless torching is used in conjunction with pegging it will not be possible to ensure that the pegs are secured.

The problem of shrinkage and slipping can be partly overcome by using double battens, one above the other, to prevent vertical movement of the peg. A lighter batten is nailed above the peg carrying batten with sufficient space left for the wooden peg to be driven between the two. However, the cost of having the oak pegs cut and the two sets of extra timber laid prior to the slating taking place may deter all but the most enthusiastic owner from employing the traditional form of slate hanging. In general modern stone slaters will nail the slates to the battens, using copper or alloy nails which are strong yet light. Galvanised nails should not be used for when they are being hammered the coating may be damaged allowing water to penetrate and begin the process of rusting which under the great weight of the roofing slate may cause the nail to shear. In some cases where the eaves courses are especially large, double nailing is advisable in the same way as double pegging was formerly employed on eaves courses. More recently, an alloy peg has been produced to allow the slate to be hung rather than nailed.
